Manhole Inspection Summary

Manhole # S170__026MH

Insp Date: **3/13/08 11:46 AM**

Location Address: **2613 lehman st**

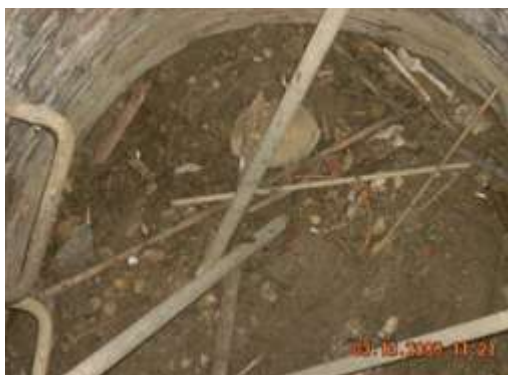
Defect 4

Condition: ☐ Sound ☐ Cracked ☐ Root Intrusion ☐ Deteriorated ☐ Leaks ☒ **Debris**

debris in channel

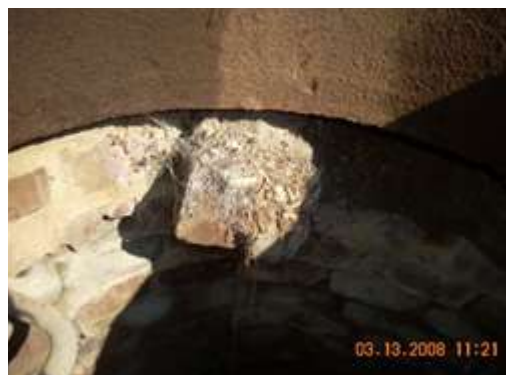
Defect 3

Condition: ☐ Sound ☐ Cracked ☐ Root Intrusion ☒ **Loose Brick** ☒ **Deteriorated**

loose chimney brick

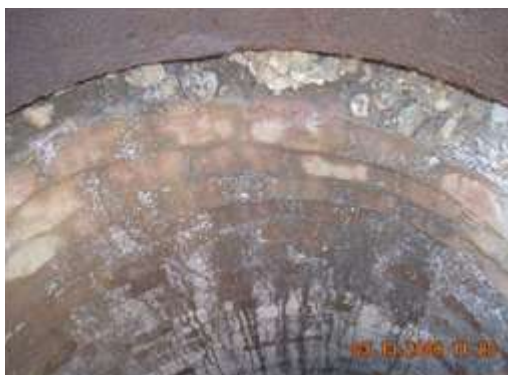
Defect 2

Infiltration: ☐ None ☒ **Joint** ☐ Cracks ☐ Mortar ☐ Roots ☐ Wall

infiltration @ the chimney joint

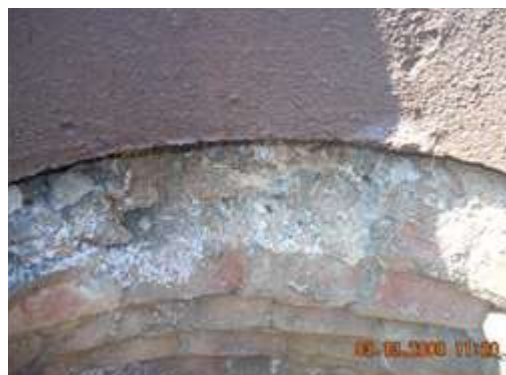
Defect 1

deteriorated chimney

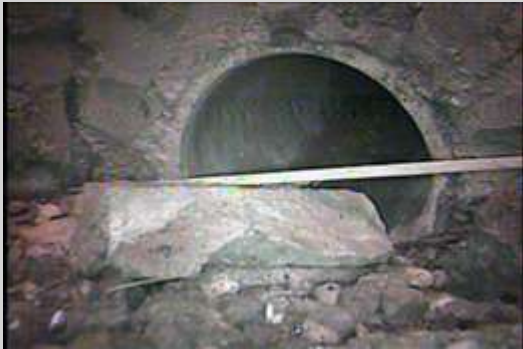
12 O'Clock Outflow

8 in. Circular Gravity Sewer
Pipe Out @ 12 O'Clock

Deposits: ☐ None ☐ Mud ☐ Sludge ☒ **Debris** ☐ Grease

Silt Depth: **3** (in.) Deposits Extent: **Light**
